DAM DISTRESS & DAM FAILURES

EXAMPLES & CASE-STUDIES

IIT-Roorkee
19 January, 2024

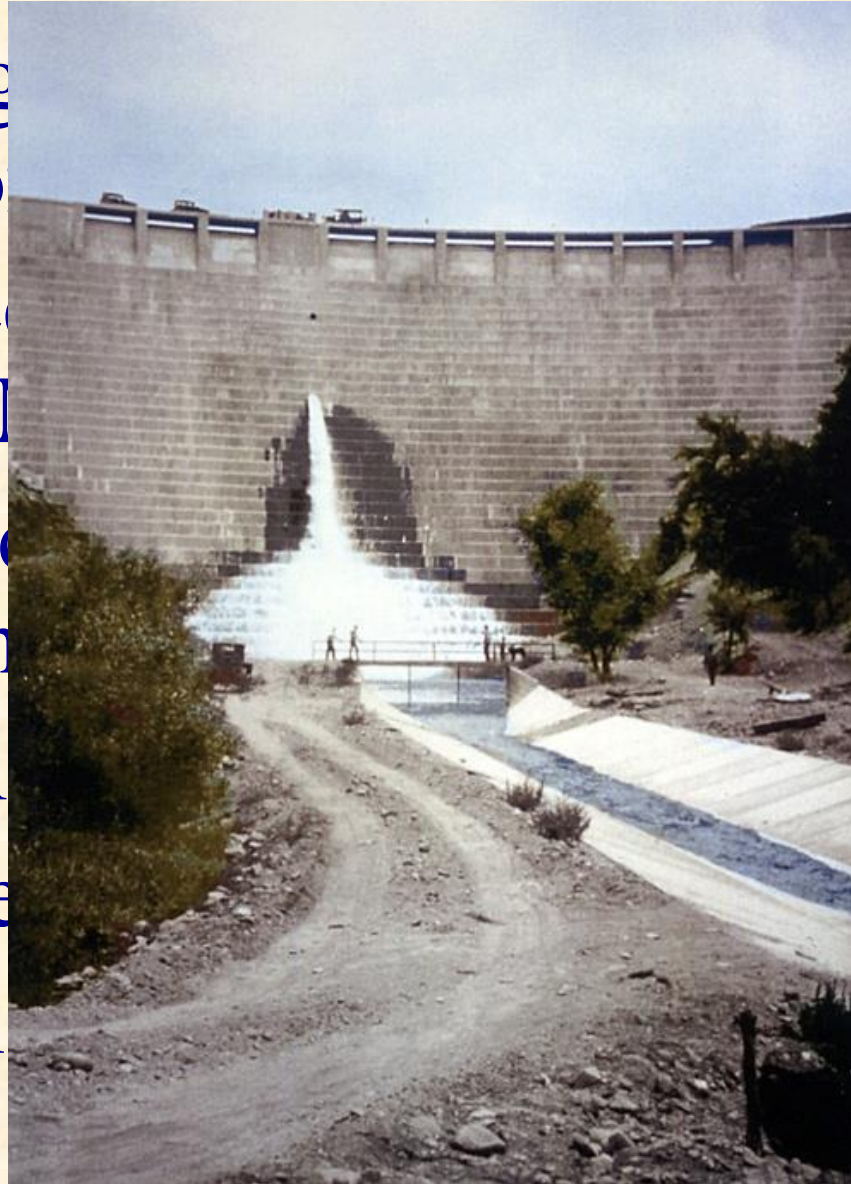
St. Francis Dam Failure

- Concrete gravity dam located 64 km northwest of San Francisco, California.
- Built between 1917 and 1930 under supervision of William L. Blood.
- Catastrophic failure occurred 16 minutes before midnight on March 12, 1976.
- Filled to full capacity at the time of failure.
- 36,180 Acres of land were inundated.
- Resulting flood killed 43 people and destroyed over 55 miles of property.

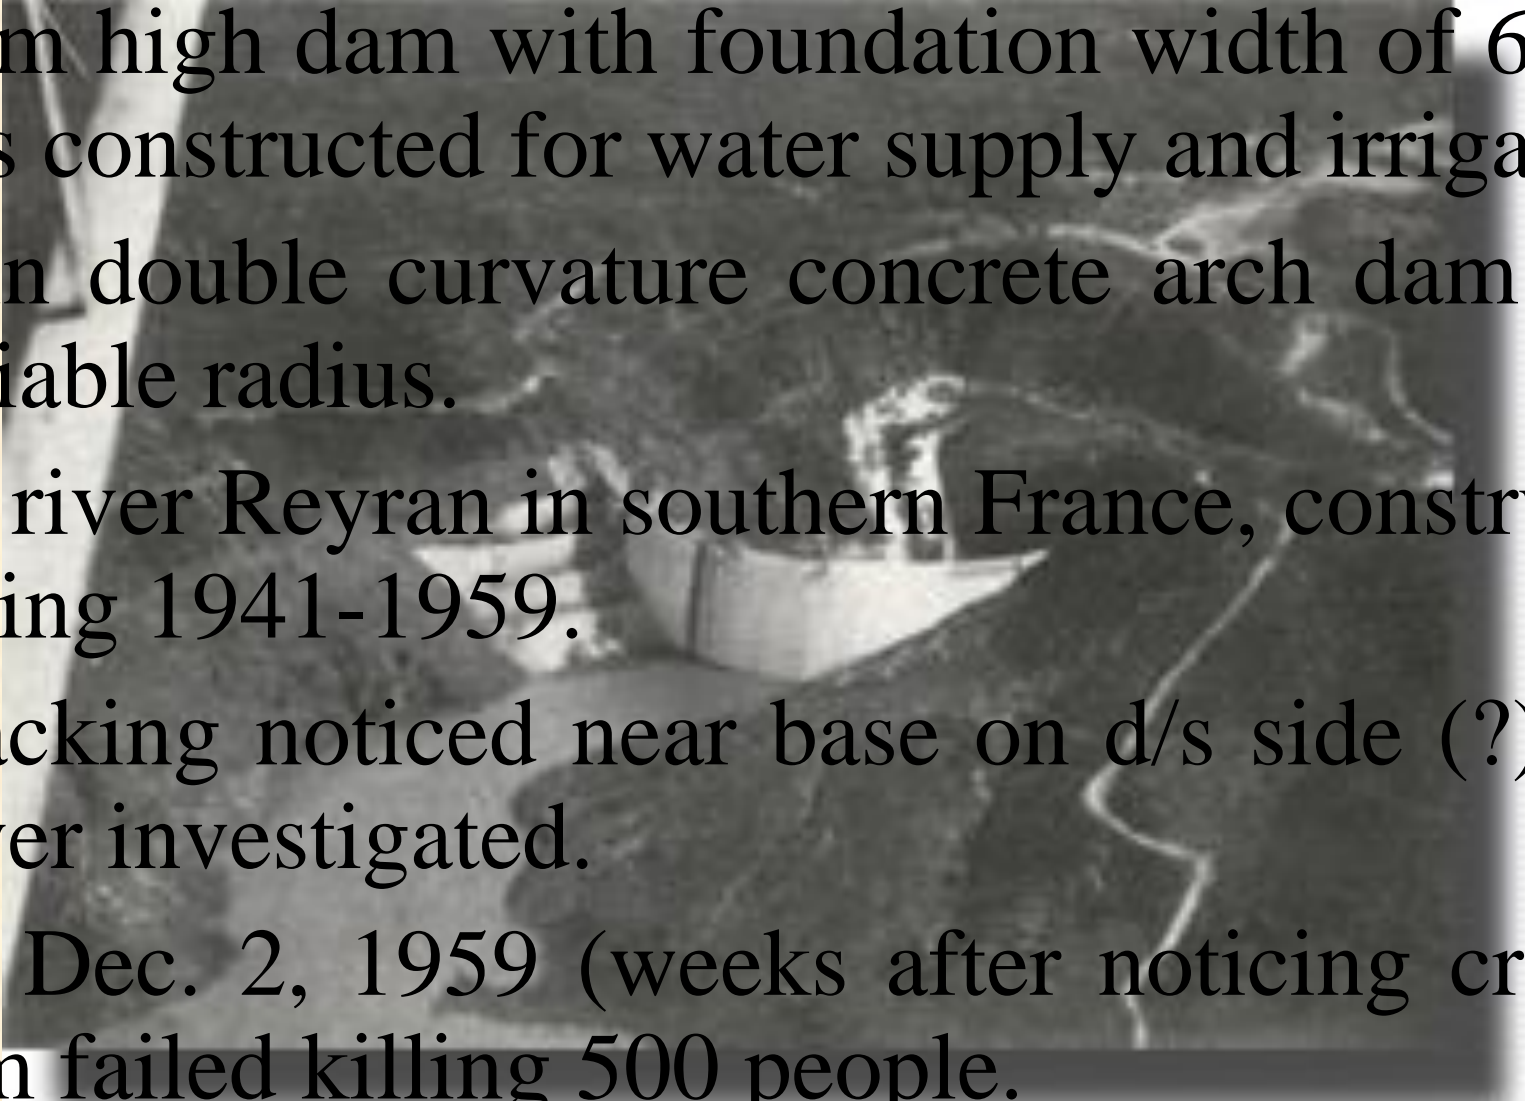
Maplasset Dam Failure

- 60 m high dam with foundation width of 6.78m was constructed for water supply and irrigation.
 - Thin double curvature concrete arch dam with variable radius.
 - On river Reyran in southern France, constructed during 1941-1959.
 - Cracking noticed near base on d/s side (?); but never investigated.
 - On Dec. 2, 1959 (weeks after noticing cracks) dam failed killing 500 people.
-

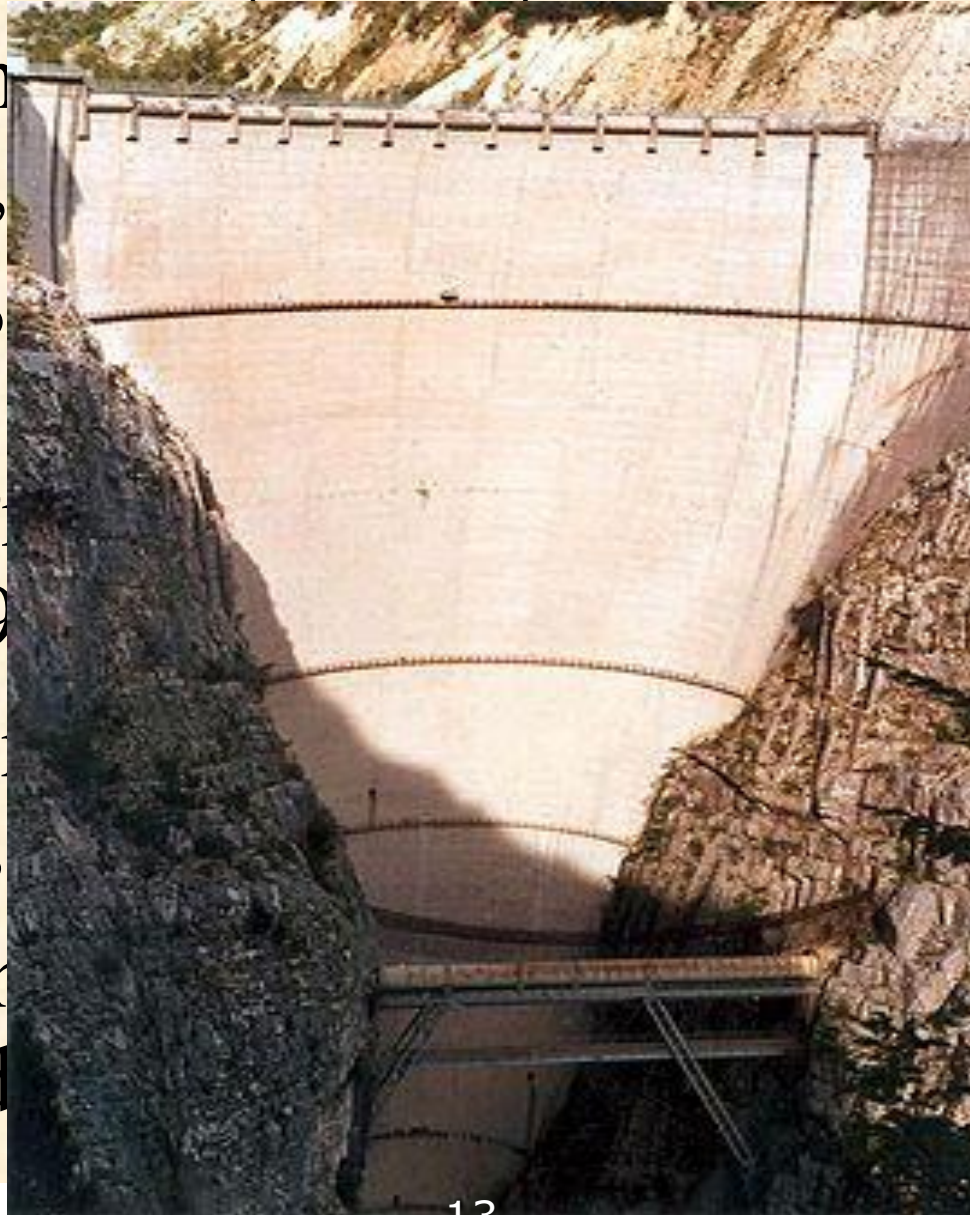
VAJONT (Vaiont) LANDSLIDE

- Vajont Dam is located on the Piave river under Monte Toc, Italy.
- Built by S. IRI for rapidly-expanding Turin and Modena. Project excavation began in 1957.
- Doubly curved concrete dam was world's tallest at the time.
- Chord of the dam is 274m, and the volume of impounded water is 1.2 billion m³.

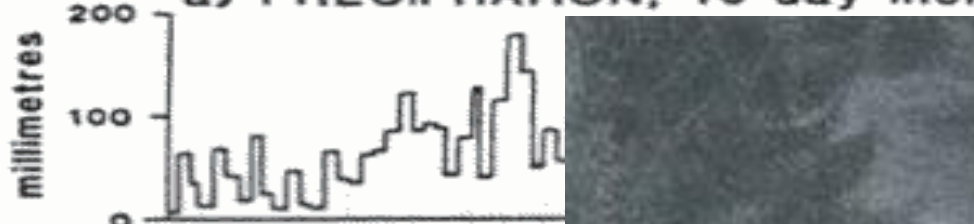
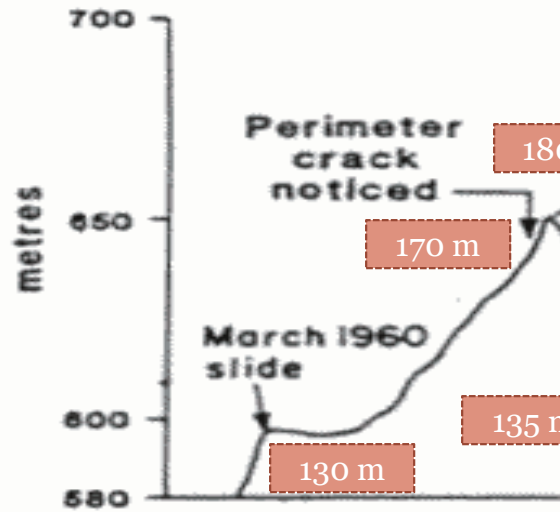
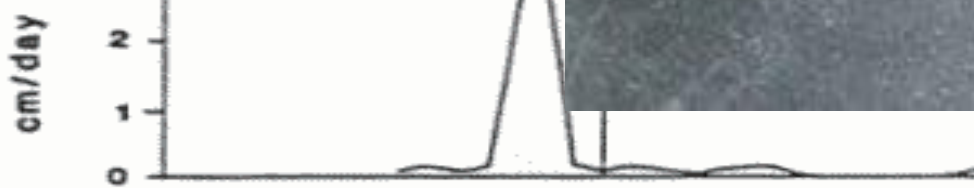
a) PRECIPITATION, 10 day inc

b) RESERVOIR

c) RATE OF MOVEMENT

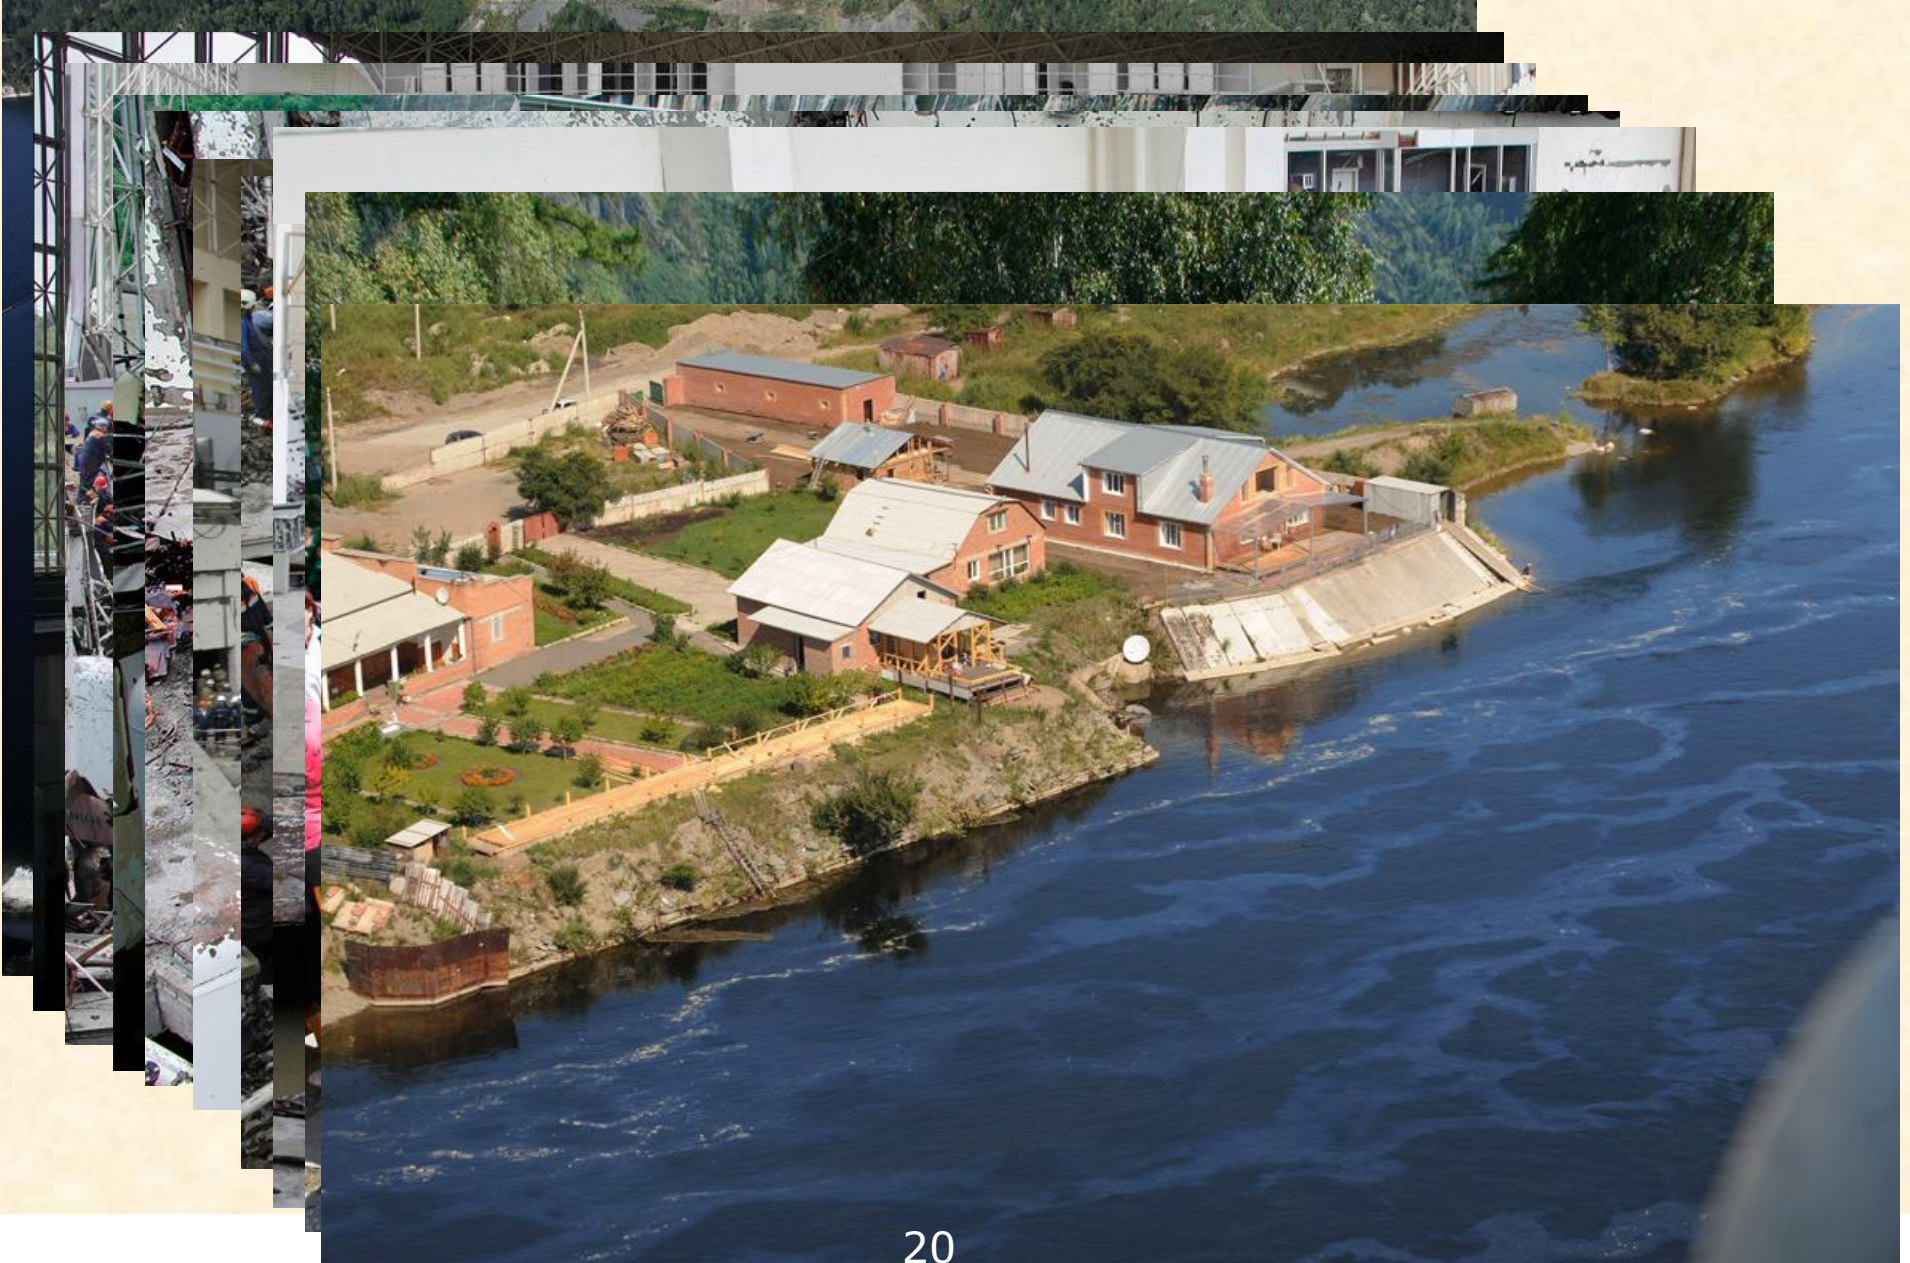
Sayano-PH Failure – Contd.

- On August 17th, 2009, near Sayanogorsk in south central Russia, a catastrophic accident took place in the turbine and transformer rooms of the hydroelectric plant of the Sayano-Shushenskaya dam.
- Water from Yenisei River flooded turbine room, causing at least one transformer explosion and extensive damage to all ten turbines, destroying at least three of them.
- 74 workers lost their lives in the accident.
- 40 tons of transformer oil spilled into the river, killing about 400 tons of trout.

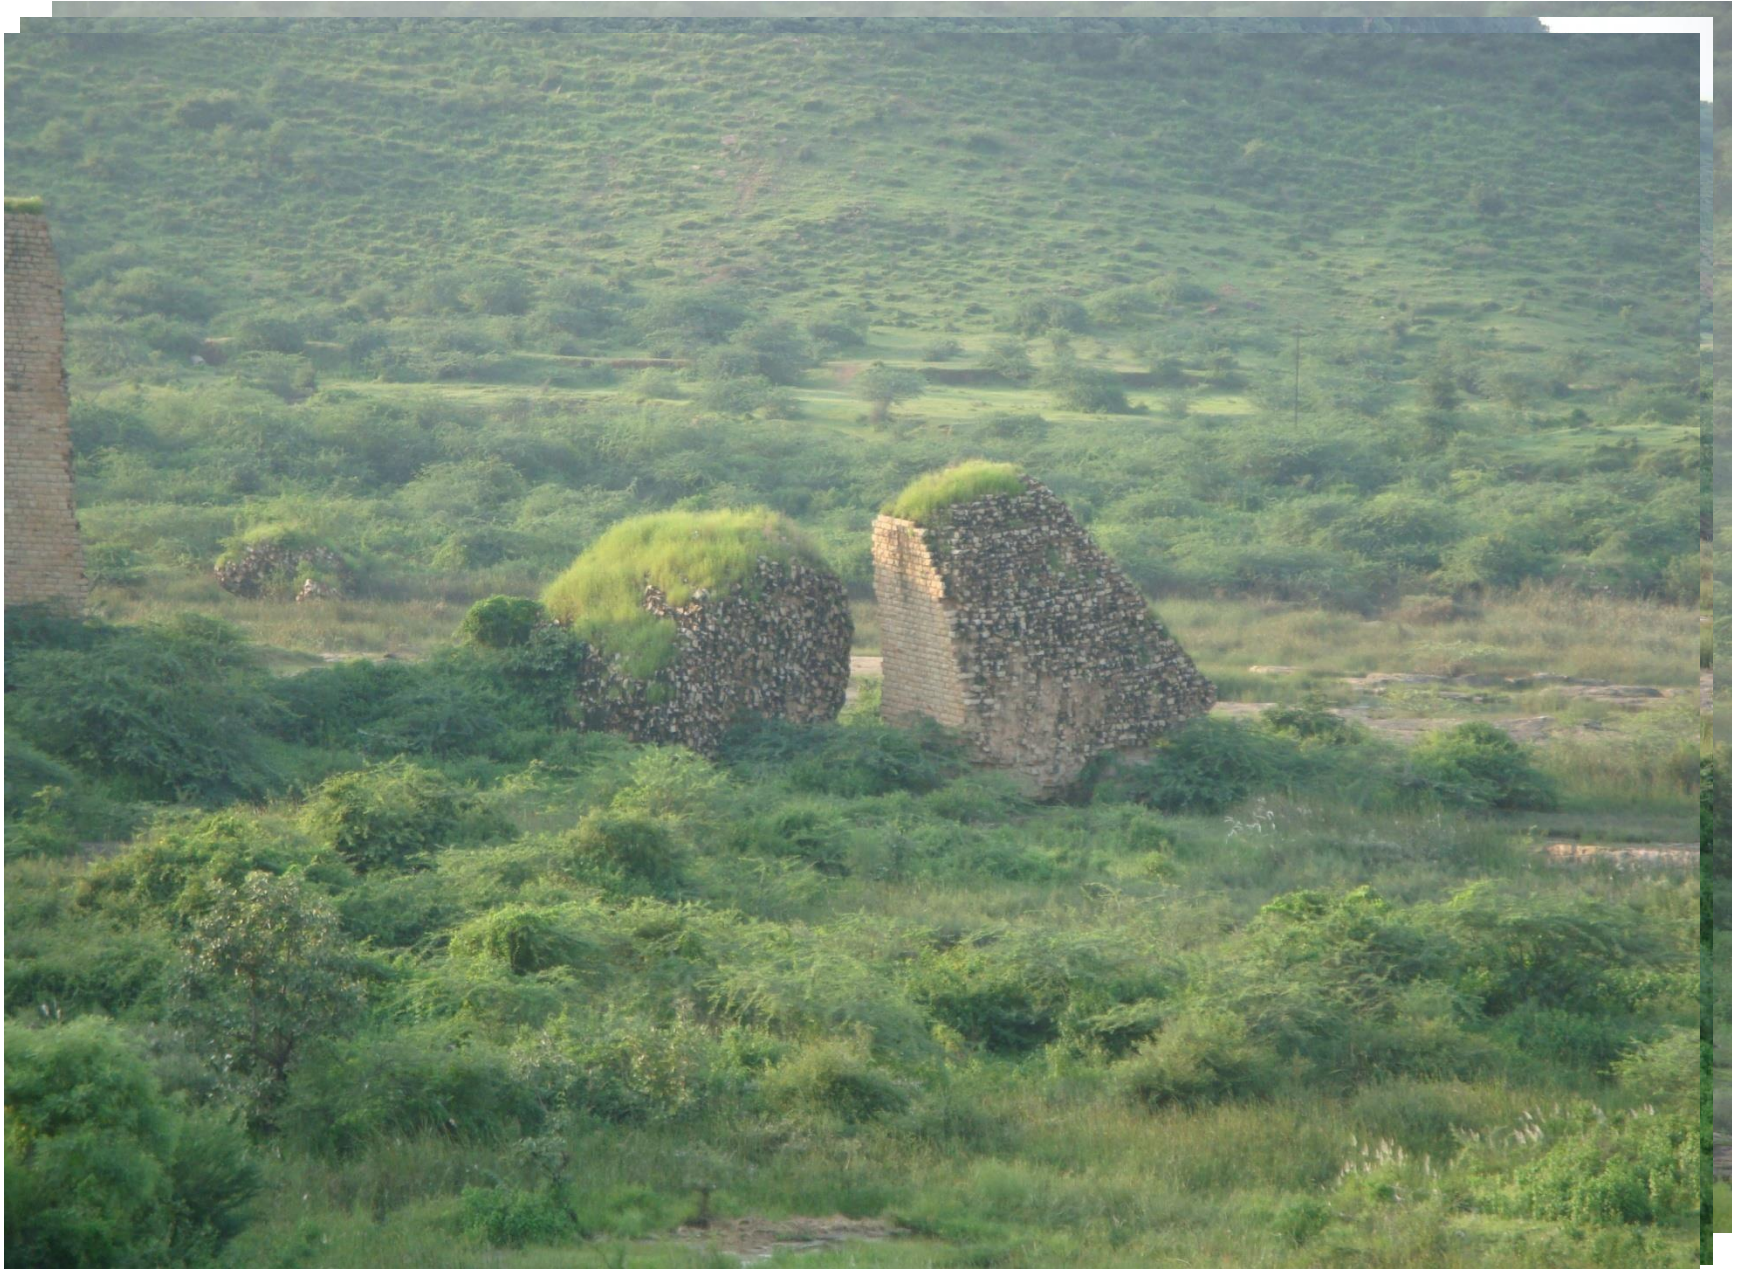
Tigra Dam Failure

- Originally meant for irrigation, Tigra dam is single source of drinking water for Gwalior.
- 1520 m long (1340 m masonry, 180 m earth dam) with max. height of 25m.
- Completed in year 1916, some length of non-overflow dam failed on 4th August 1917.
- Founded on fissured sand stone rock, dam failure reported due to uplift pressure.
- Dam reconstructed bw. 1919 – 1929.
