DAM DISTRESS & DAM FAILURES

EXAMPLES & CASE-STUDIES

IIT-Roorkee
19 January, 2024

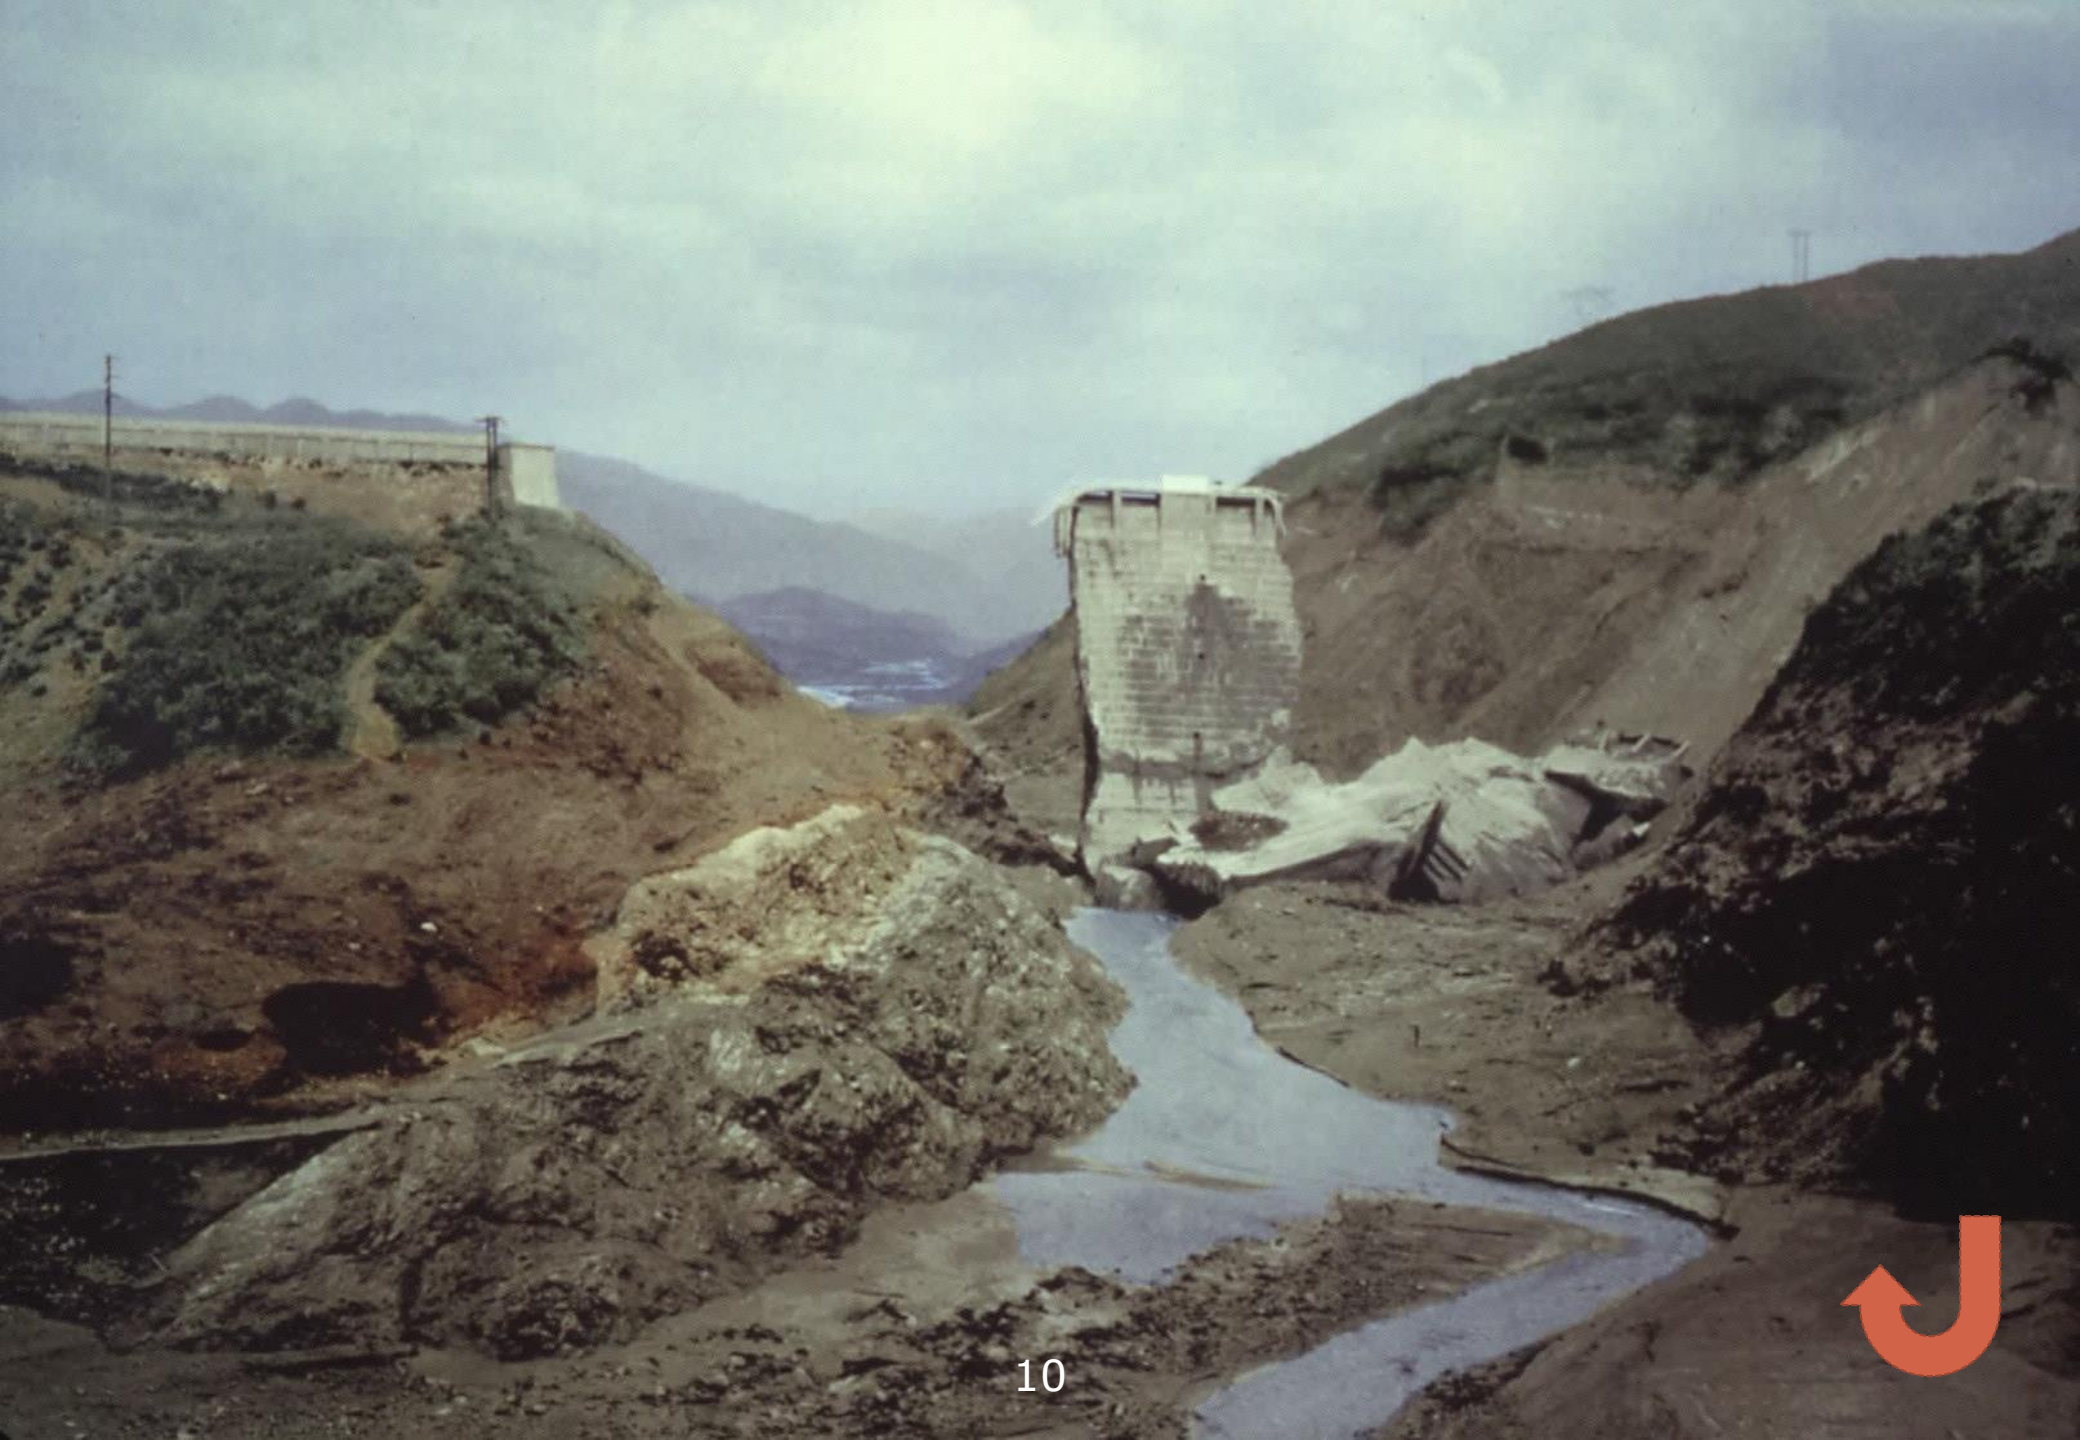
Maplasset Dam Failure

- 60 m high dam with foundation width of 6.78m was constructed for water supply and irrigation.
 - Thin double curvature concrete arch dam with variable radius.
 - On river Reyran in southern France, constructed during 1941-1959.
 - Cracking noticed near base on d/s side (?); but never investigated.
 - On Dec. 2, 1959 (weeks after noticing cracks) dam failed killing 500 people.
-
